Protected Lane Assessment Chelmsford City (Additional Lanes)

Chelmsford City Council

November 2017

EB 088

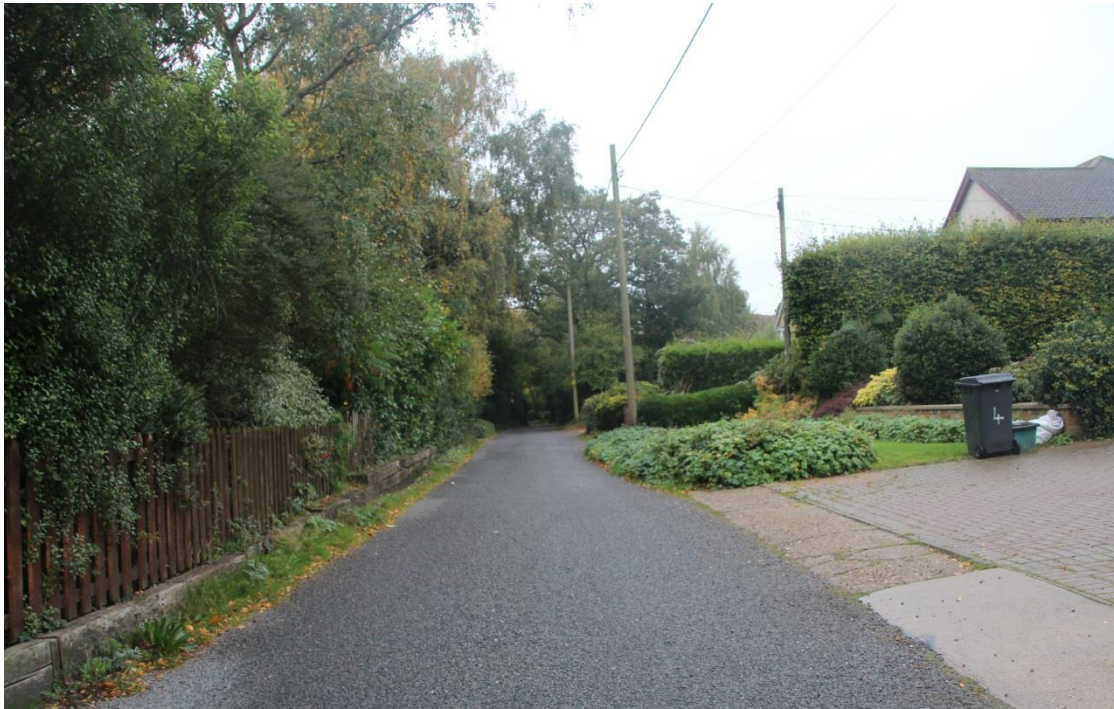
Figure 2 - Property entrances along Hyde Lane

While the lane is a historic route its historic integrity is no longer intact due to the extensive highway improvements and property entrances that have been put in place (Figure 2, Figure 3, Figure 4). Many of the garden boundaries abut the lane and the historic verges, ditches and hedgerows have been removed and replaced with kerbs and block paving (Figure 2).

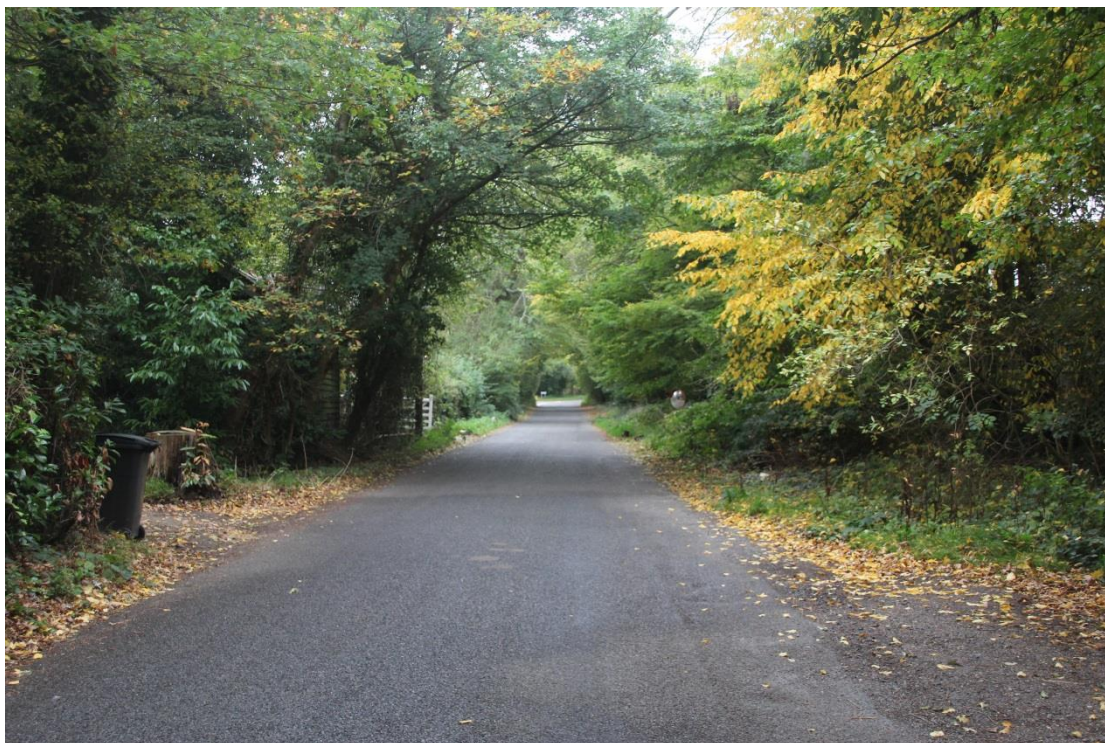
Figure 5 - Property entrances at the south end of Hyde Lane

However, once south of the junction with Capons Lane, there are several widened driveways with kerb stones, some areas of erosion in passing places and removal of traditional hedgerows. The number of property entrances (properties that are more recent than the 1st Edition OS mapping), increase towards the road junction and these have again cut through and removed the historic boundaries, ditches and verges (Figure 5).

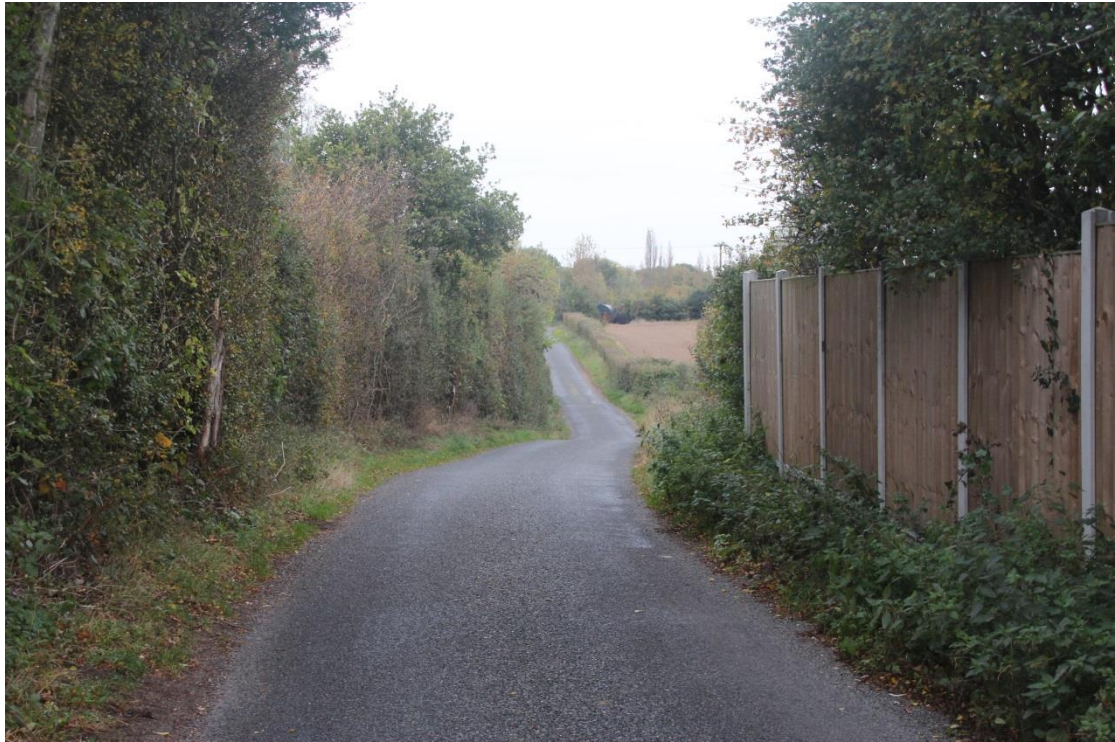
Figure 6 - Southern end (start) of Twitty Fee

This lane is just over 650m long and is a no-through road. The entrance has been widened with road markings, kerb stones and fencing around a modern property (Figure 6). The lane is narrow and while there has been major hedgerow loss on the right hand side this has been replanted. The lane is both undulating and sinuous in places.

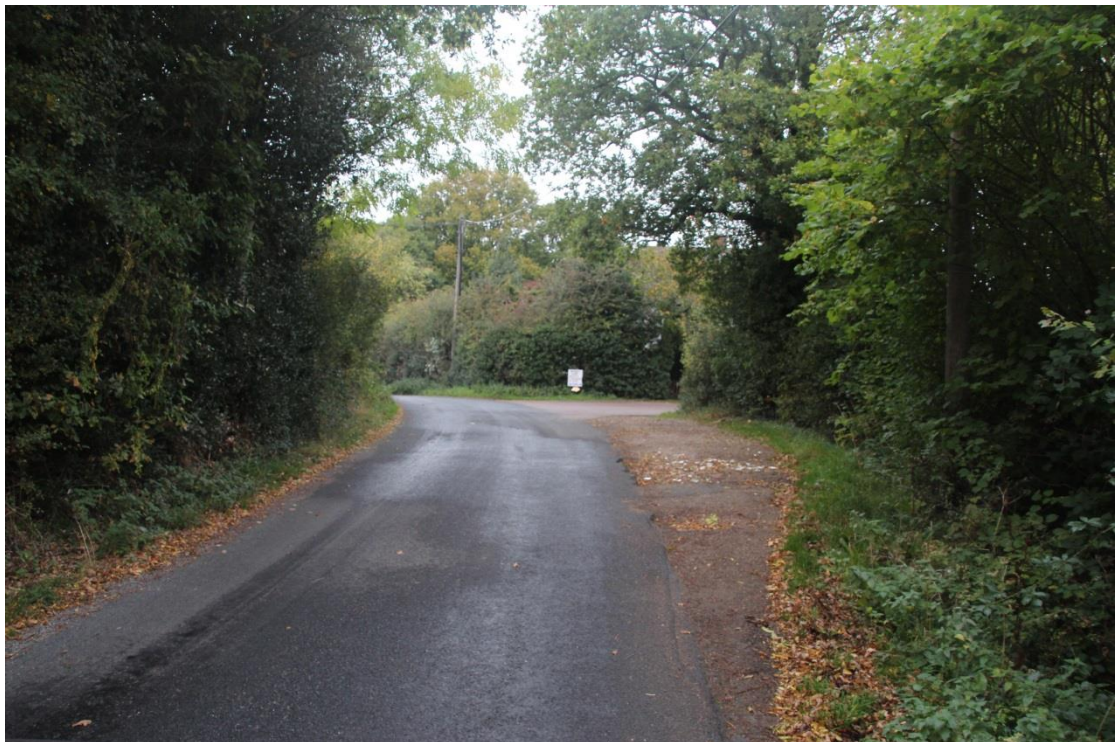
Figure 7 - Erosion in passing/parking space on bend

There has been some widening of field entrances that has resulted in erosion, along with some erosion in passing places along the lane (Figure 7); although this is limited along its length.

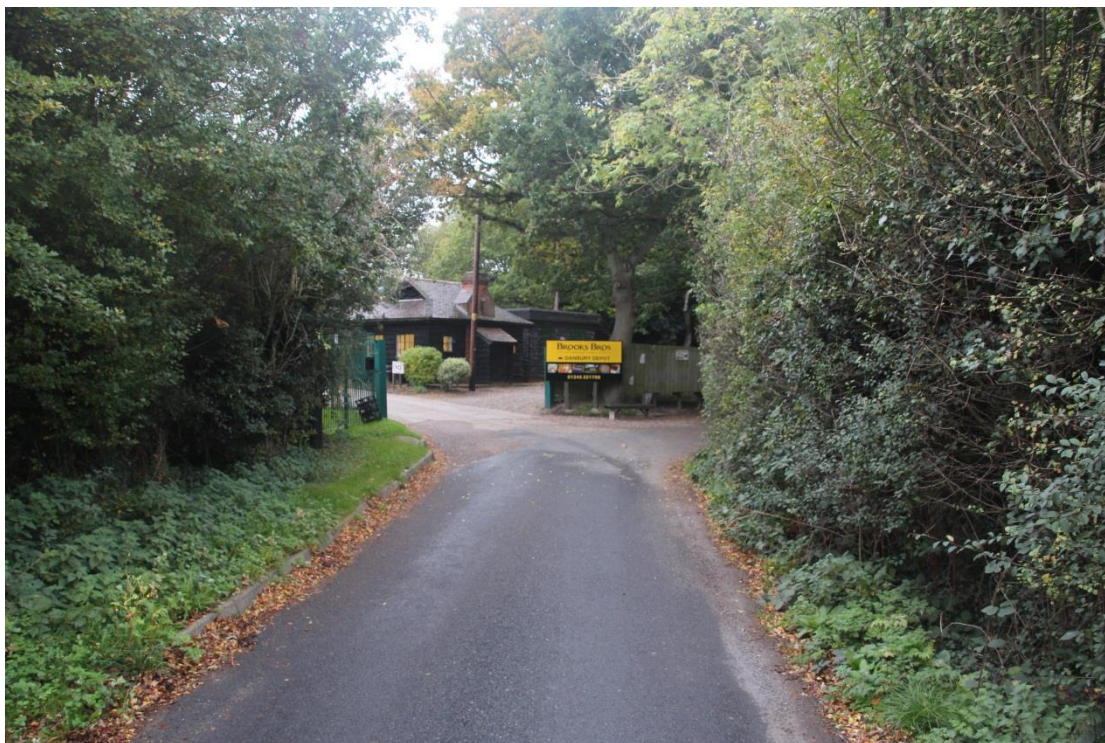
Figure 8 - Entrance to wood yard with new fencing and kerb stones

Some highway improvements (kerb stones) have been put in place where the entrance to the wood yard has been widened and this also has some modern fencing and signage (Figure 8), but it is relatively unobtrusive and limited.

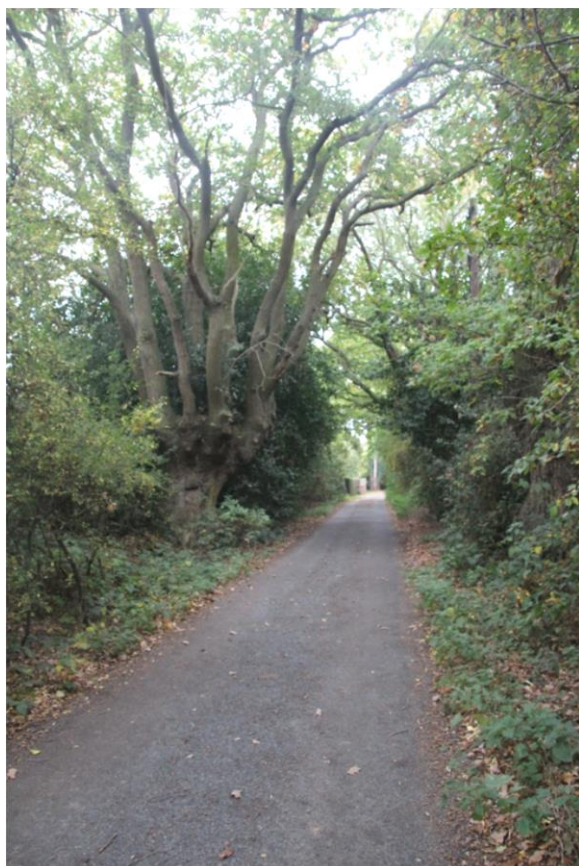
Figure 9 - Veteran pollard on woodland bank

The lane narrows after the wood yard and property with an overhanging canopy, banks, multispecies hedgerow in places and veteran pollards (Figure 9).

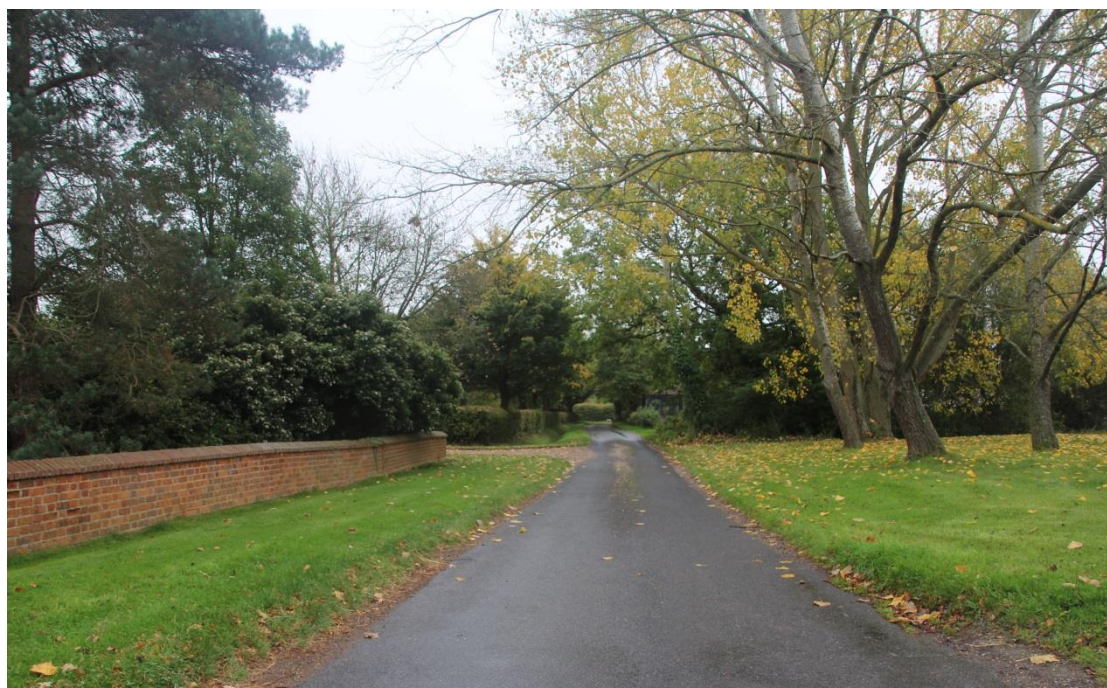
Figure 10 - Western end of Tyndales Lane

Tyndales Lane was originally assessed in 2010. This lane is just over 460m long and is in two sections with Hyde Lane crossing it. The junction of the two sections of Tyndales Lane is staggered. The western end of the lane is short (c. 145m), although it is open with wide, well-kept grass verges on both sides and the lane itself is narrow (Figure 10). The lane is very straight with little diversity of features (similar width, form and direction) and much of the historic integrity has been lost due to property entrances.

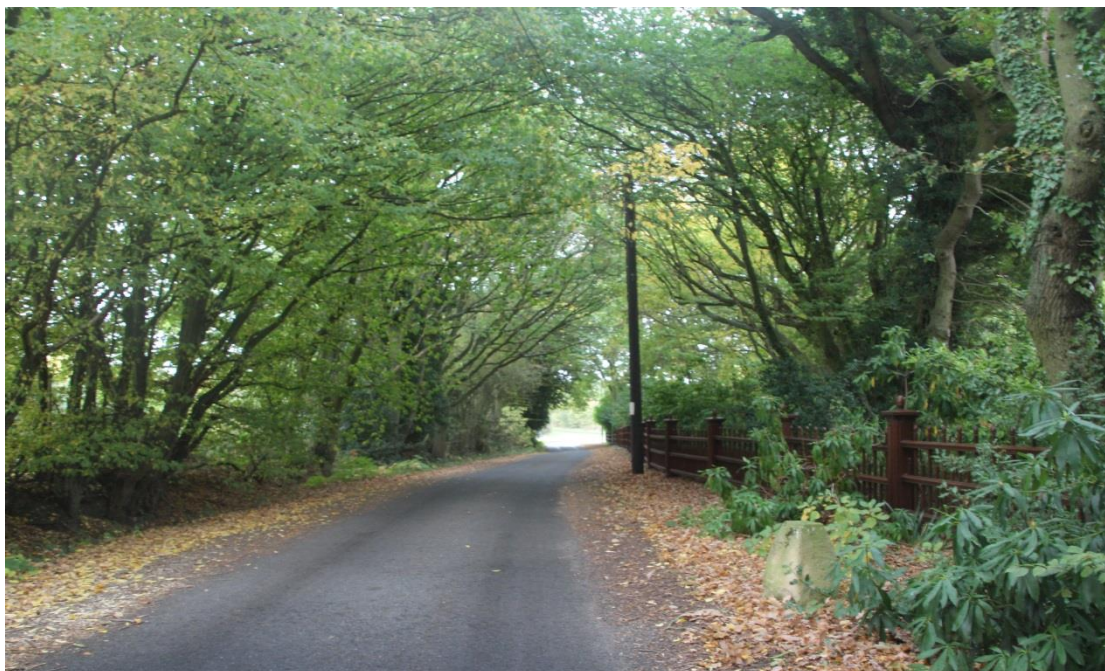
Figure 11 - Coppiced stools on low level bank with modern fencing opposite

There are good examples of coppiced stools on a low level bank at the eastern end of the lane, but opposite this a new modern fence and laurel hedging has replaced any historic features that may have existed (Figure 11).

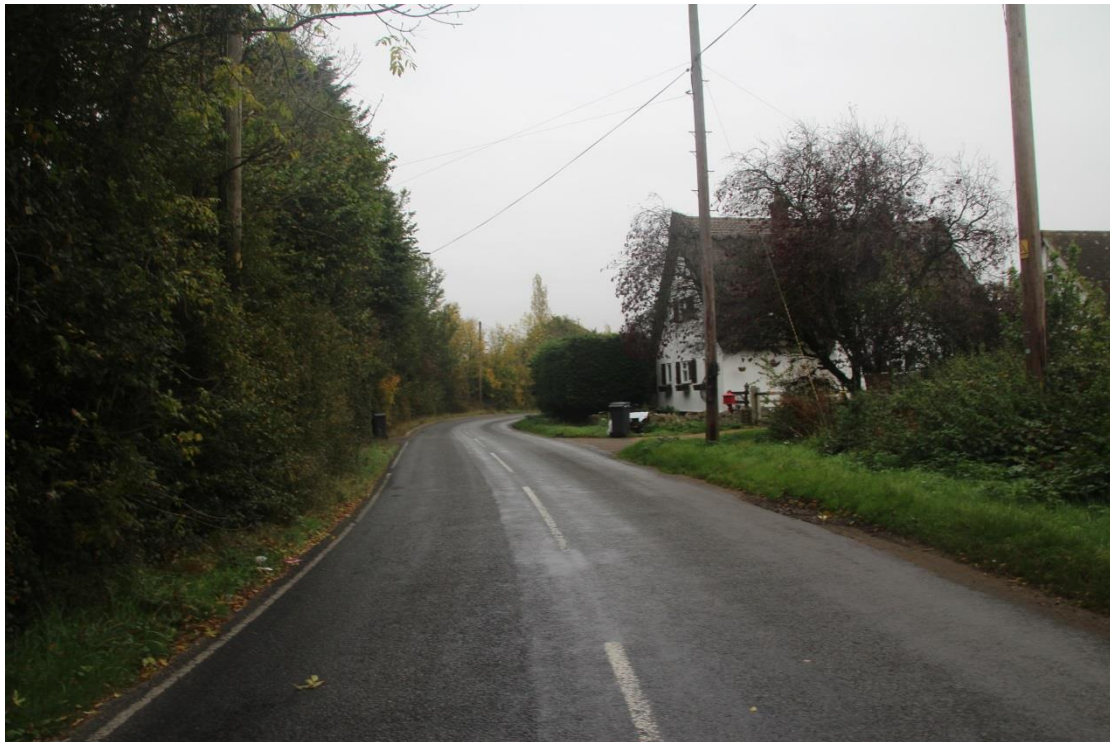
Figure 12 - Western end of Slough Road with property entrance

Slough Road was a new proposed lane and had not been previously assessed. As it was a new lane the full length of the lane (approximately 1km) was assessed. However, it was found that the initial 100m of the western end have many highway improvements (kerb stones, signage) and a property entrance (Figure 12) so it was decided to begin the lane assessment at the end of the property boundary.

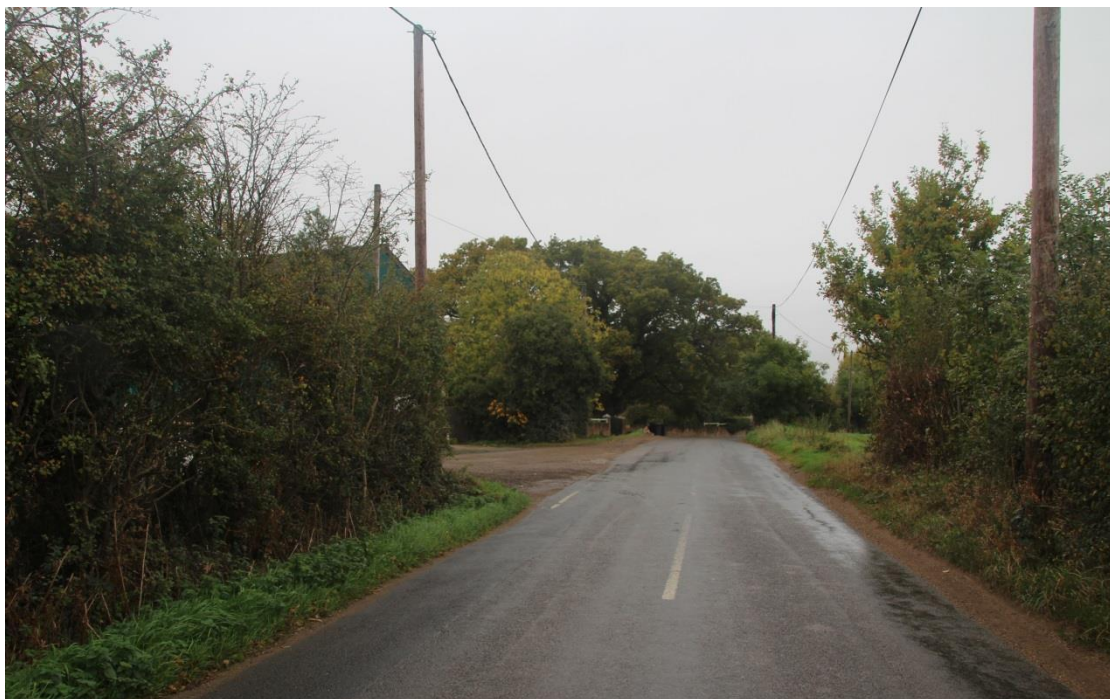
Figure 13 - Erosion and widening at farm entrance

The farm entrances have been widened and show some evidence of erosion (Figure 13), however, these farm complexes with their Listed Buildings contribute to the overall group value and aesthetics of the lane.

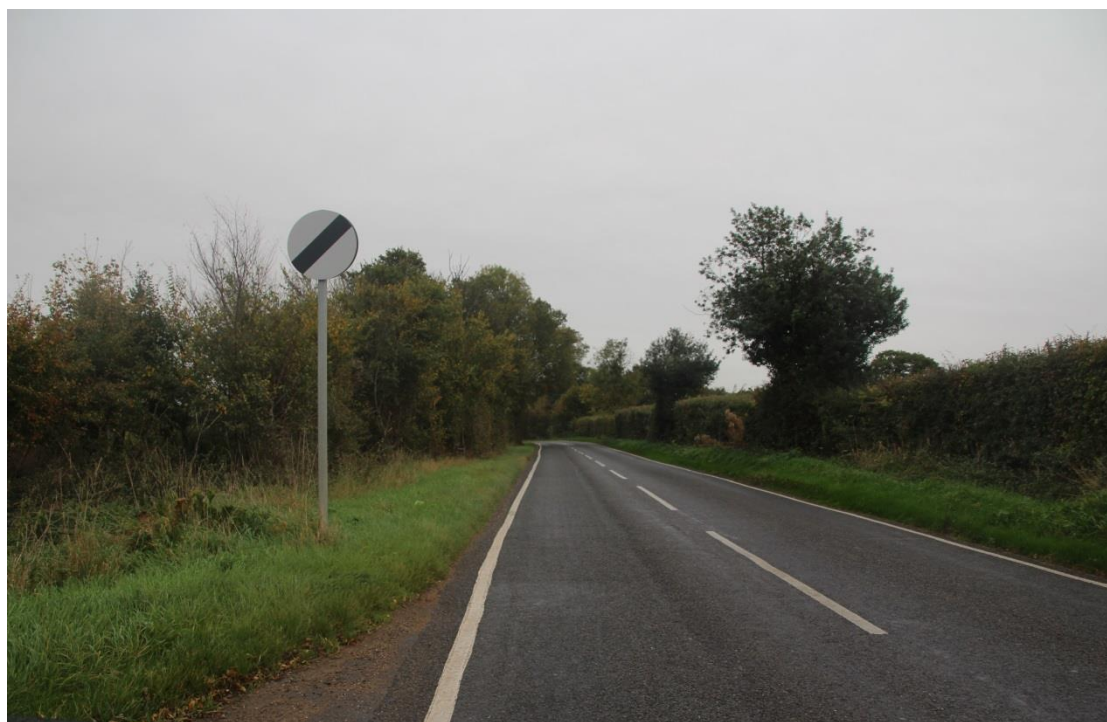
Figure 14 - Start of Herbage Park Road

At the start of this road there is a large area of erosion and modern road signs on a wide and very busy road (Figure 14).

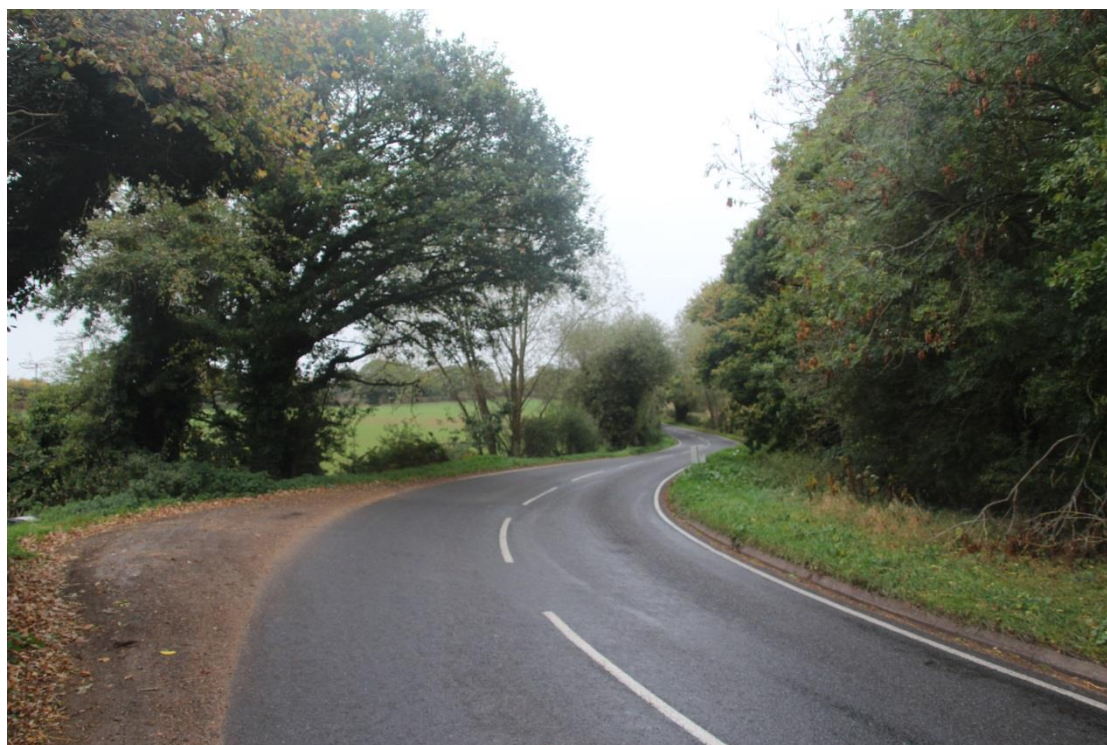
Figure 15 - Erosion and kerb stones on corner of Herbage Park Road

Despite how busy the road is it does retain some of its historic integrity, with banks, verges and ditches visible along much of its length. There is limited hedgerow loss along the length and there is only erosion in a limited number of places (Figure 15).

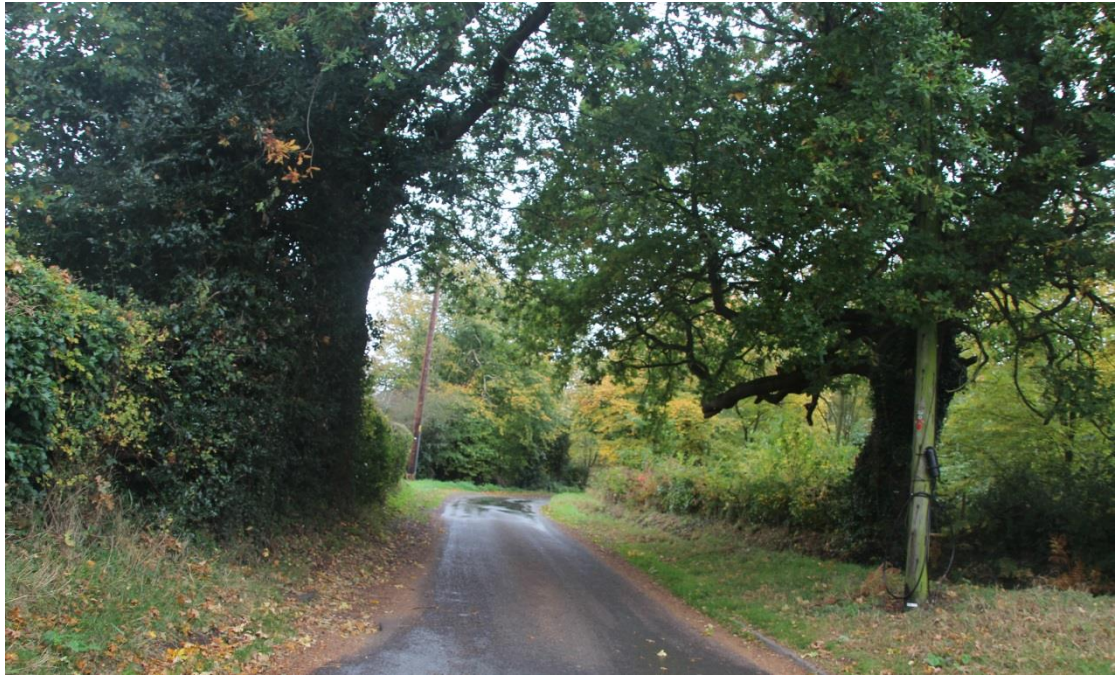
Figure 16 - Start of Gay Bowers Road (north east end)

The north-eastern end of the lane, at the junction with Capons Lane, has kerb stones and a narrow sloping verge (Figure 16). The lane is narrow and has some oak pollards along the verge. These verges, with banks and ditches in places, continue for c. 50-60m. The lane has several driveways many of which are not marked on the 1st edition OS mapping. While the nursing home is historic (some of the buildings are listed), the entrance has been improved (Figure 17) and the historic boundary features (such as hedgerows) have been removed.

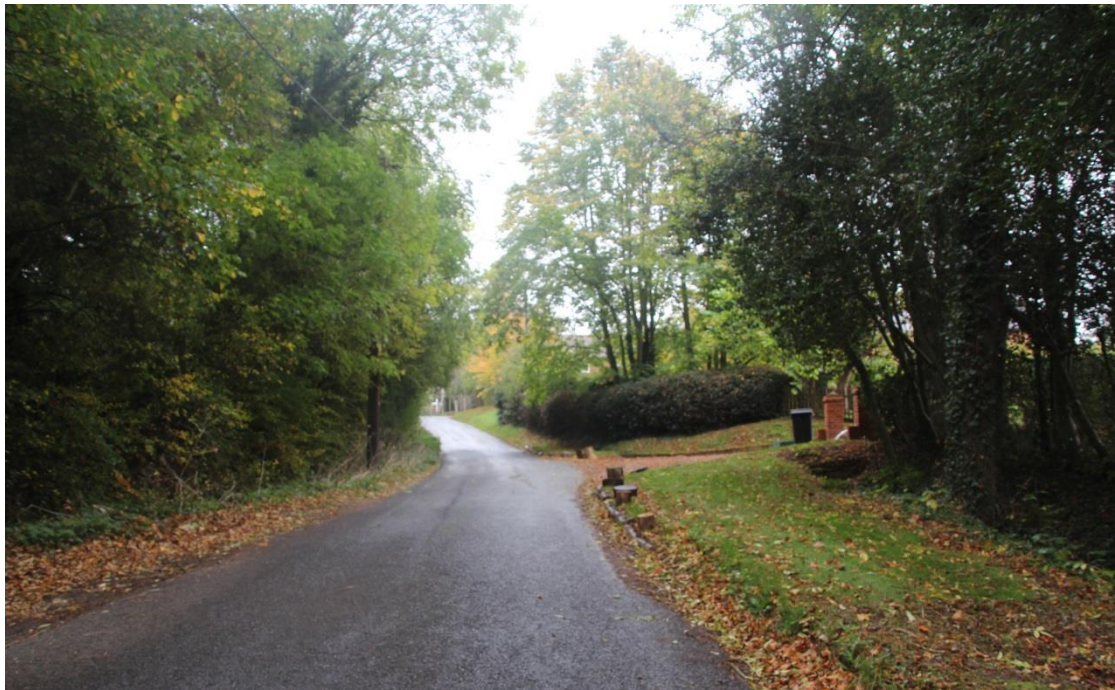
Figure 18 - Property entrance at western end of assessed lane

After the nursing home there is a single further property entrance (Figure 18) before the start of the Protect Lane. The new driveways, signage, hedgerow removal and new entrances to the nursing home all reduce the historic integrity of this section of the lane. The historic integrity of the south-west end of the lane is good, with limited highway improvements and little loss to the historic fabric of the lane.
