# Broomfield Conservation Area

**Conservation area  
Character Appraisal**

# **Broomfield Conservation Area**

**Status:**  
Consultation Draft

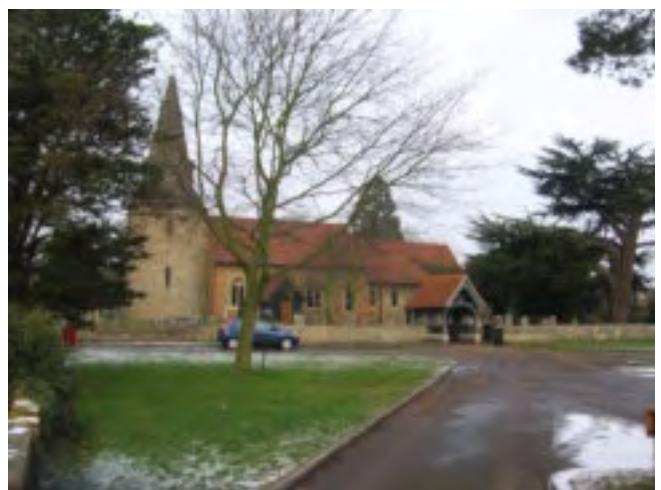
Figure 3 - St Mary's Church from the south

Further development during the Norman period is evident in St Mary's church (figure 3): the round tower was added in the early twelfth century.

St Mary's Church (see figures 3, 12 and 13) is of immense historic and architectural interest, is an important facility for the local community and a landmark.

It is possible that there was an earlier timber framed church on the site, but the earliest remaining phase of building is the nave and western end of the chancel, which date from the late eleventh century. The south wall incorporates large amounts of reused Roman brick.

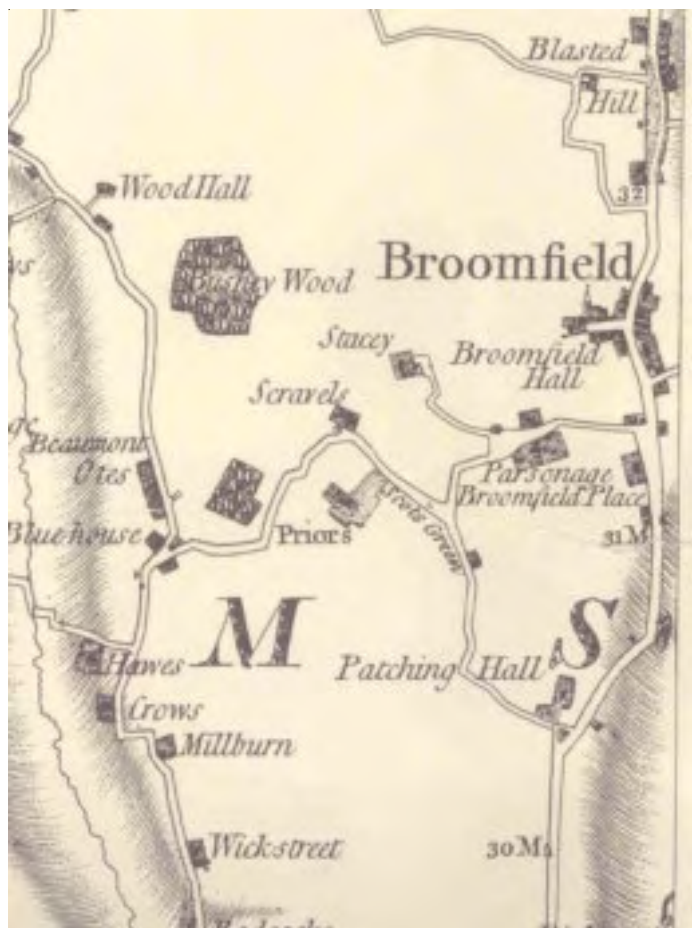
Figure 4 - The Chapman and Andre Map 1777

The Chapman and Andre Map of 1777 (figure 4) shows development around Church Green and opposite (east), on Main Road, beyond there are sporadic farmsteads, within an open landscape setting. Many of the buildings surviving today date from the eighteenth century, indicating prosperity from this period linked to agriculture.

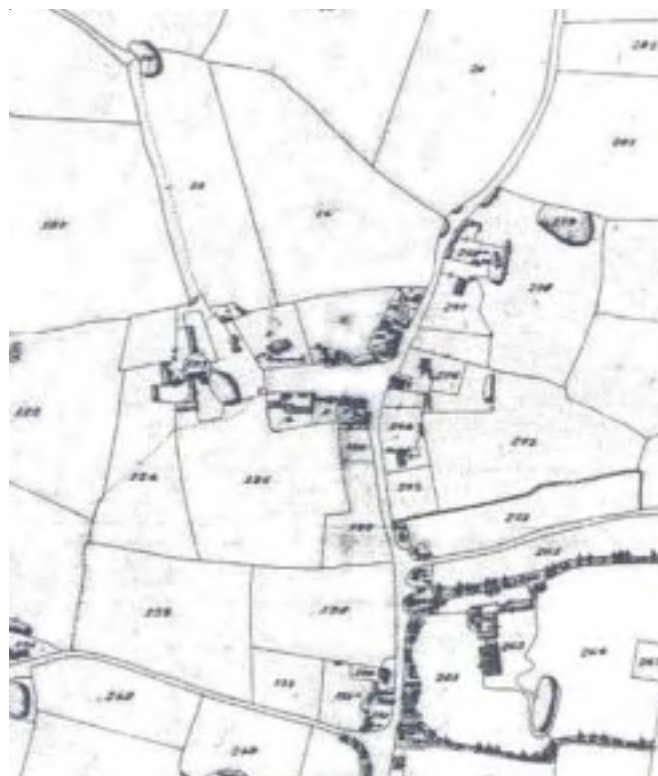
Figure 5 - The Tithe Map 1840

The Tithe Map of 1840 (figure 5) shows the built development around Church Green clearly, with a group of farm buildings surrounding the hall. The start of gradual ribbon development along the Main Road is also evident. From the late eighteenth century there were a number of High Status houses built along the Main Road between Broomfield and Chelmsford, including Broomfield Place (c.1820), Brooklands (c.1826), Broomfield Lodge (demolished) and Brownings (demolished).

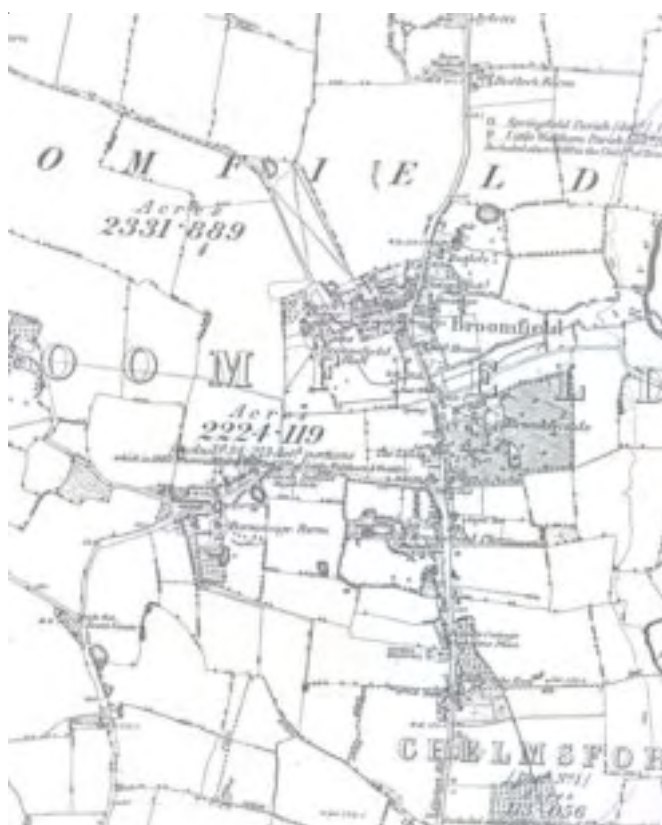
Figure 6 - 1st edition OS map 1878

From the late nineteenth century (figure 6, 1878) there was extensive housing development along the Main Road, serving the expanding population of Chelmsford, spurred on by improved sanitation and rail links. A vicarage and school are shown on the west side of Main Road and a nursery to the north of Church Green.

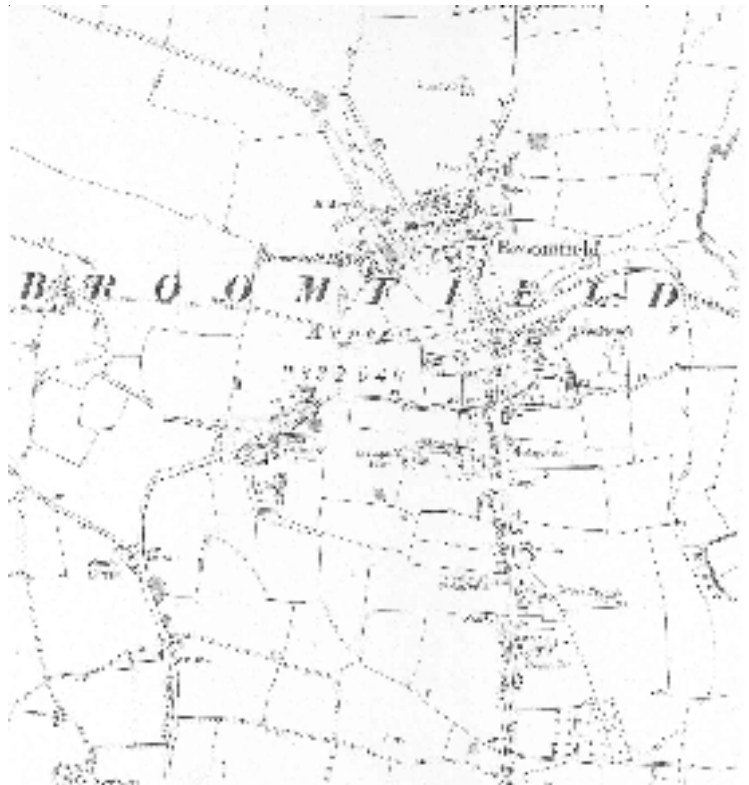
Figure 7 - Second edition ordnance survey map 1897

The second edition ordnance survey map, 1897 (figure 7) shows development of further housing on the west side of Main Road and a layout largely as today.

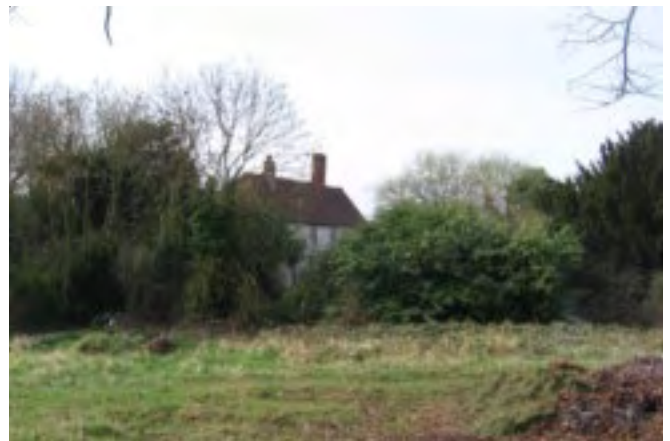
*Figure 17 - The Hall*

The Hall (figure 17) is a large L-plan building, originally a fifteenth century hall house, extensively altered and extended in the seventeenth century, with the addition of the south west wing and substantial chimney stack. It is timber framed and plastered with a plain tiled roof. The grounds are extensive and well treed. The rural landscape beyond is an essential feature of its setting. There is a strong historic and visual relationship with the Church.

The Hall is a large timber framed building, set in extensive grounds. It can be glimpsed from Church Green and from the south and west, but it is almost entirely enclosed by trees (see figure 17).

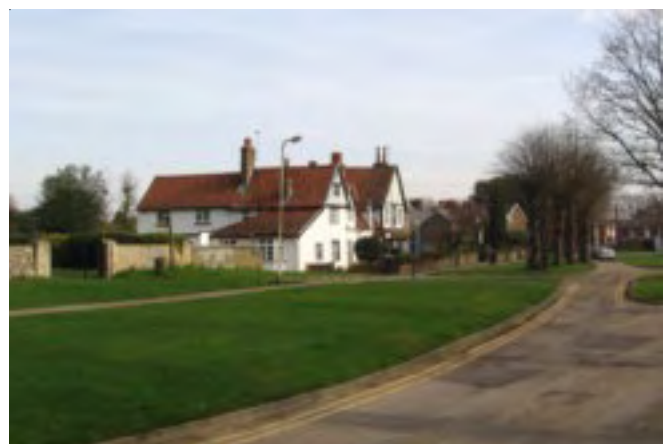
*Figure 18 - 16 and 18 Church Green*

Originally one dwelling, probably the vicarage. A sixteenth century hall house, typical to Essex, with a low central open hall and two storey cross wings to either end (figure 18). Timber framed and plastered, with applied decoration to the eastern crosswing. Open garden setting to the rear providing a strong sense of status and openness and a backdrop. A prominent feature on the green, with a strong visual relationship with the Church.

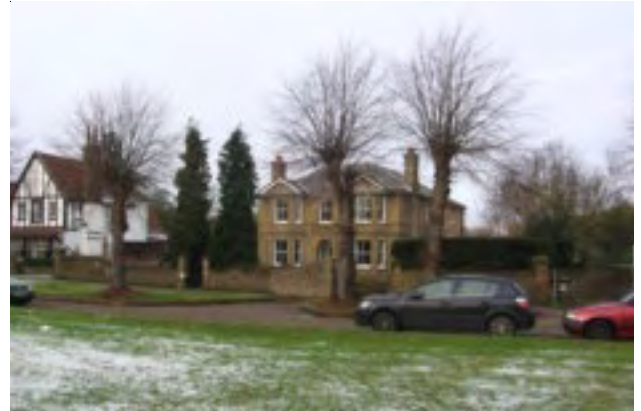
Figure 19 - Church Green

A detached late nineteenth century villa, 1885, built on part of a nursery gardens run by the owners of the Vineries (figure 19). Two storeys of yellow brick. Hipped slate roof, with splayed full height front bays with gabled pediments. Substantial garden forming its setting and part of the open grounds north of Church Green. Low brick wall to front in matching brick. Part of a group of Victorian buildings on the corner of Church Green including 2-6 (even) and 293-303 (odd) Main Road.

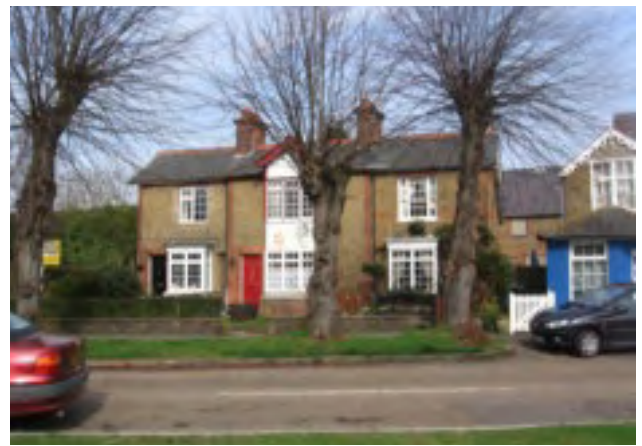
Figure 20 - 2 - 6 (even) Church Green

Terrace of three houses, late nineteenth century (figure 20). Two storey, gabled slate covered roof with ornamental orange clay ridge tiles. Yellow brick with red brick dressings. Number 2 and 6 with ground floor bays, Number 4 with a 2 storey bay. Part of a group of Victorian buildings including 12 Church Green and 293-303 (odd) Main Road, brickwork matching the latter.

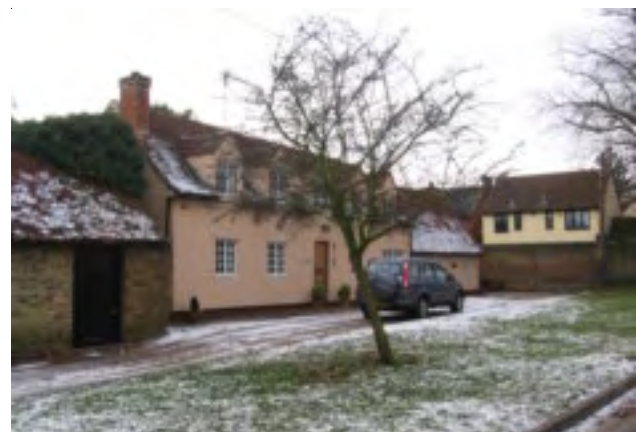
Figure 21 - Woolards, Church Green

Woolards is a range of modest eighteenth century (figure 21), timber framed and plastered cottages, now converted into a single dwelling. 1 ½ storeys with five dormers to the front. Single storey range to the west end. Important garden setting to the rear with mature trees.

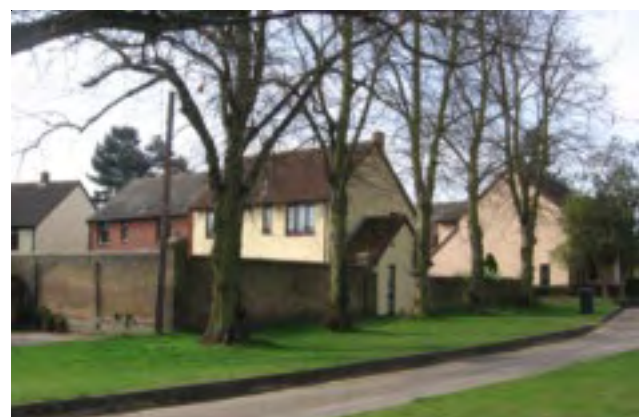
Figure 22 - Church Green opposite St Mary's Church

On the south side of Church Green are a group of 12 houses, by Raymond Ball of John S Wood Chartered Surveyors, c.1975. They were designed using the principles of the Essex Design Guide, with a vernacular form and materials, based around a loose courtyard.

They are of a scale and layout which respects the sensitive setting opposite the church (figure 22). The north side is most successful, in particular number 19 with its splayed bay windows and hedged boundary. Beyond to the south the housing is less inspired, but remains a good exponent of design guide housing, which significantly raised the standards from the mid 1970s.

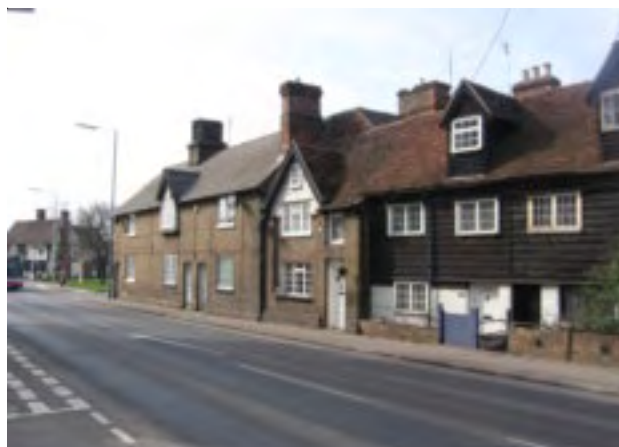
*Figure 23 - 293 - 303 Main Road*

Terraced brick building (figure 23), two storeys, residential and commercial uses, hall to rear. Yellow brick with red brick dressings. Gabled slate roof with decorative barge boards. Gable and plain tiled roof to number 303, possibly incorporating an earlier building. Some replacement doors and windows which detract from the appearance of the building.

6. 293-303 Main Road is a prominent and attractive late nineteenth century terrace, the mixture of windows (see figure 23), particularly the UPVC replacement, detracts from the overall uniformity and quality of the building. Reinstatement of traditional joinery would enhance the building's appearance.
7. Main Road is dominated by the utilitarian lamp post and telephone posts and wires, which detract from the setting of the buildings (figure 43). If the opportunity arises, relocation of services below ground and replacement of the lamp posts with simple high quality units would be an enhancement.

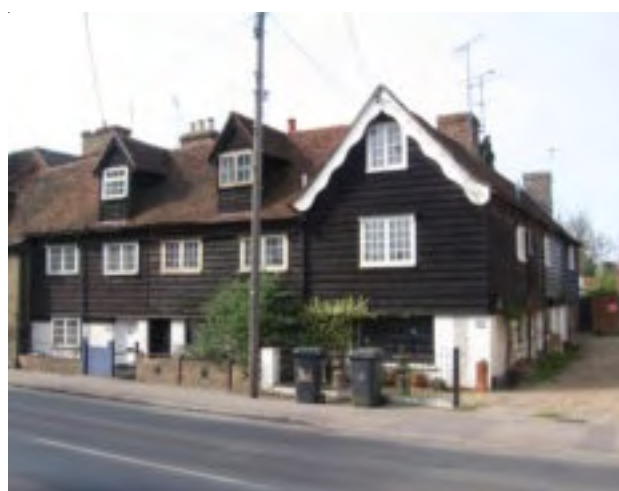
*Figure 24 - 305 - 313 Main Road*

L-plan range of eighteenth century cottages (figure 24). 2 ½ storeys, plain tiled roof with dormers and crosswing at the northern end. Rare surviving original weatherboard cladding. Brickwork to ground floor. Decorative barge boards. Glimpse views across rear gardens. A mixture of front boundary treatments detract from the simple uniformity of the buildings. Part of a group of eighteenth century houses with 315 and 321 Main Road.

5. The boundary treatments to the front of 307-309 Main Road are a mixture of modern brick walls and railings and appear disjointed in front of the uniform terrace (see figure 24), replacement could take the form of a uniform brick wall or railings.

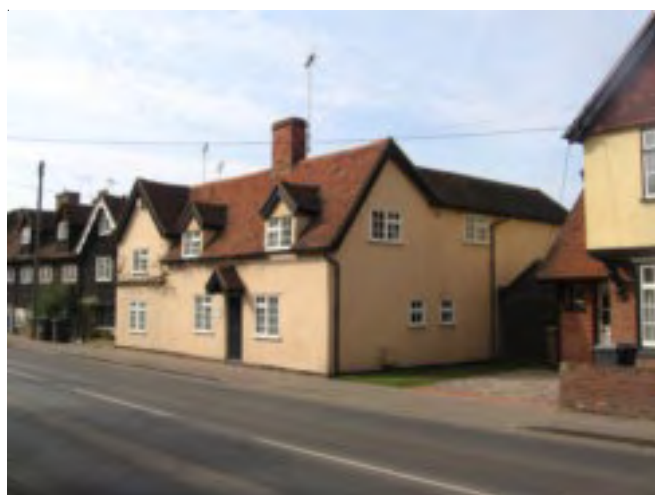
*Figure 25 - 315 Main Road, The Old Bake*

The Old Bake House (figure 25), timber framed cottage of eighteenth century origin. Timber framed and plastered. Crosswing to the southern end. Main range 1 ½ storeys, with dormers. Rear twentieth century extensions. Part of a group of eighteenth century house with 305-313 (odd) and 321 Main Road.

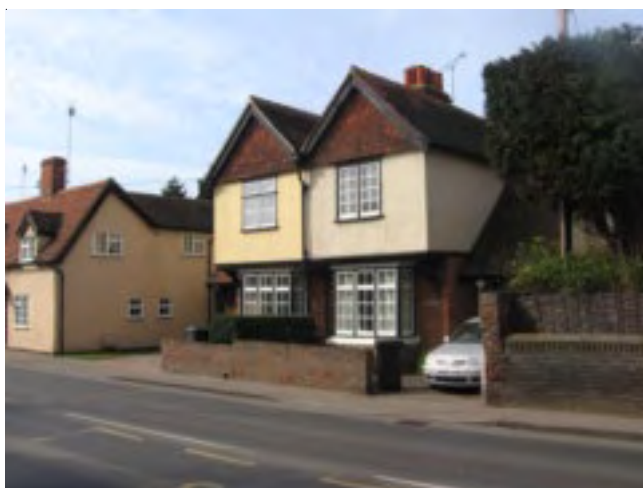
*Figure 26 - 317 - 319 Main Road*

Semi detached pair late nineteenth or early twentieth century houses (figure 26). 2 storeys, with jettied upper floors, ground floor red brick with bay windows, first floor rendered, gables clad in plain tiles. Low brick wall and hedge to front boundary.

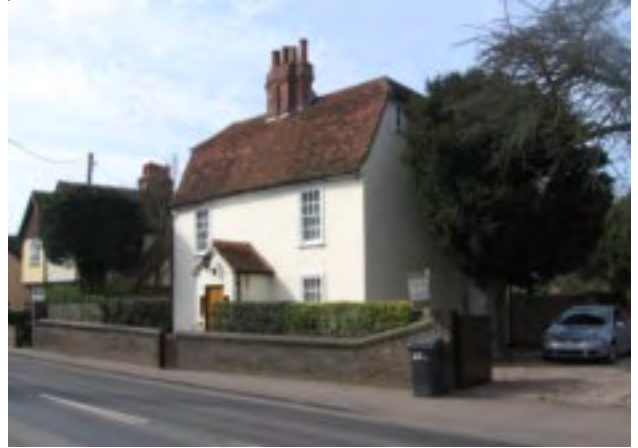
*Figure 27 - 321 Main Road*

Two storey eighteenth century house (figure 27). Timber framed and plastered. Plain tile roof with half hips, central chimney stack. Small paned sash windows. Part of a group of listed buildings along Main Road. Part of a group of eighteenth century houses with 305-313 (odd) and 315 Main Road.

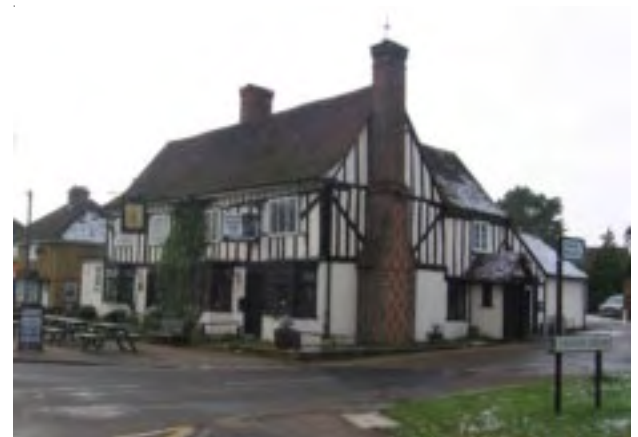
*Figure 28 - Kings Arms Public House*

Sixteenth or seventeenth century timber framed Inn (figure 28). Exposed timber framing to the first floor. Extensively restored in the early twentieth century, when the bay windows, lead lights and northern chimney stack with diaper pattern were introduced. A prominent landmark on the edge of Church Green. Seating and advertising clutter to its forecourt detract from its appearance at times.

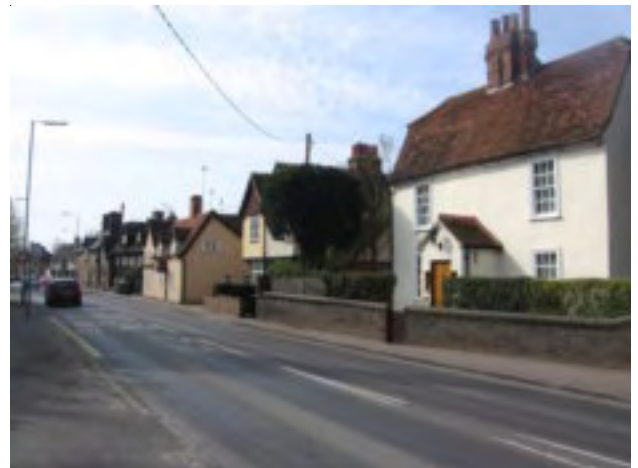
*Figure 30 - Main Road variety of built form*

The buildings are all of low domestic scale, either 1 ½, 2 or 2 ½ storeys high. There is a mixture of built forms with gables to the street and roof's parallel to the road, although where parallel to the road there is a consistent use of gabled dormers and porches, which give an overall unity (figure 30).

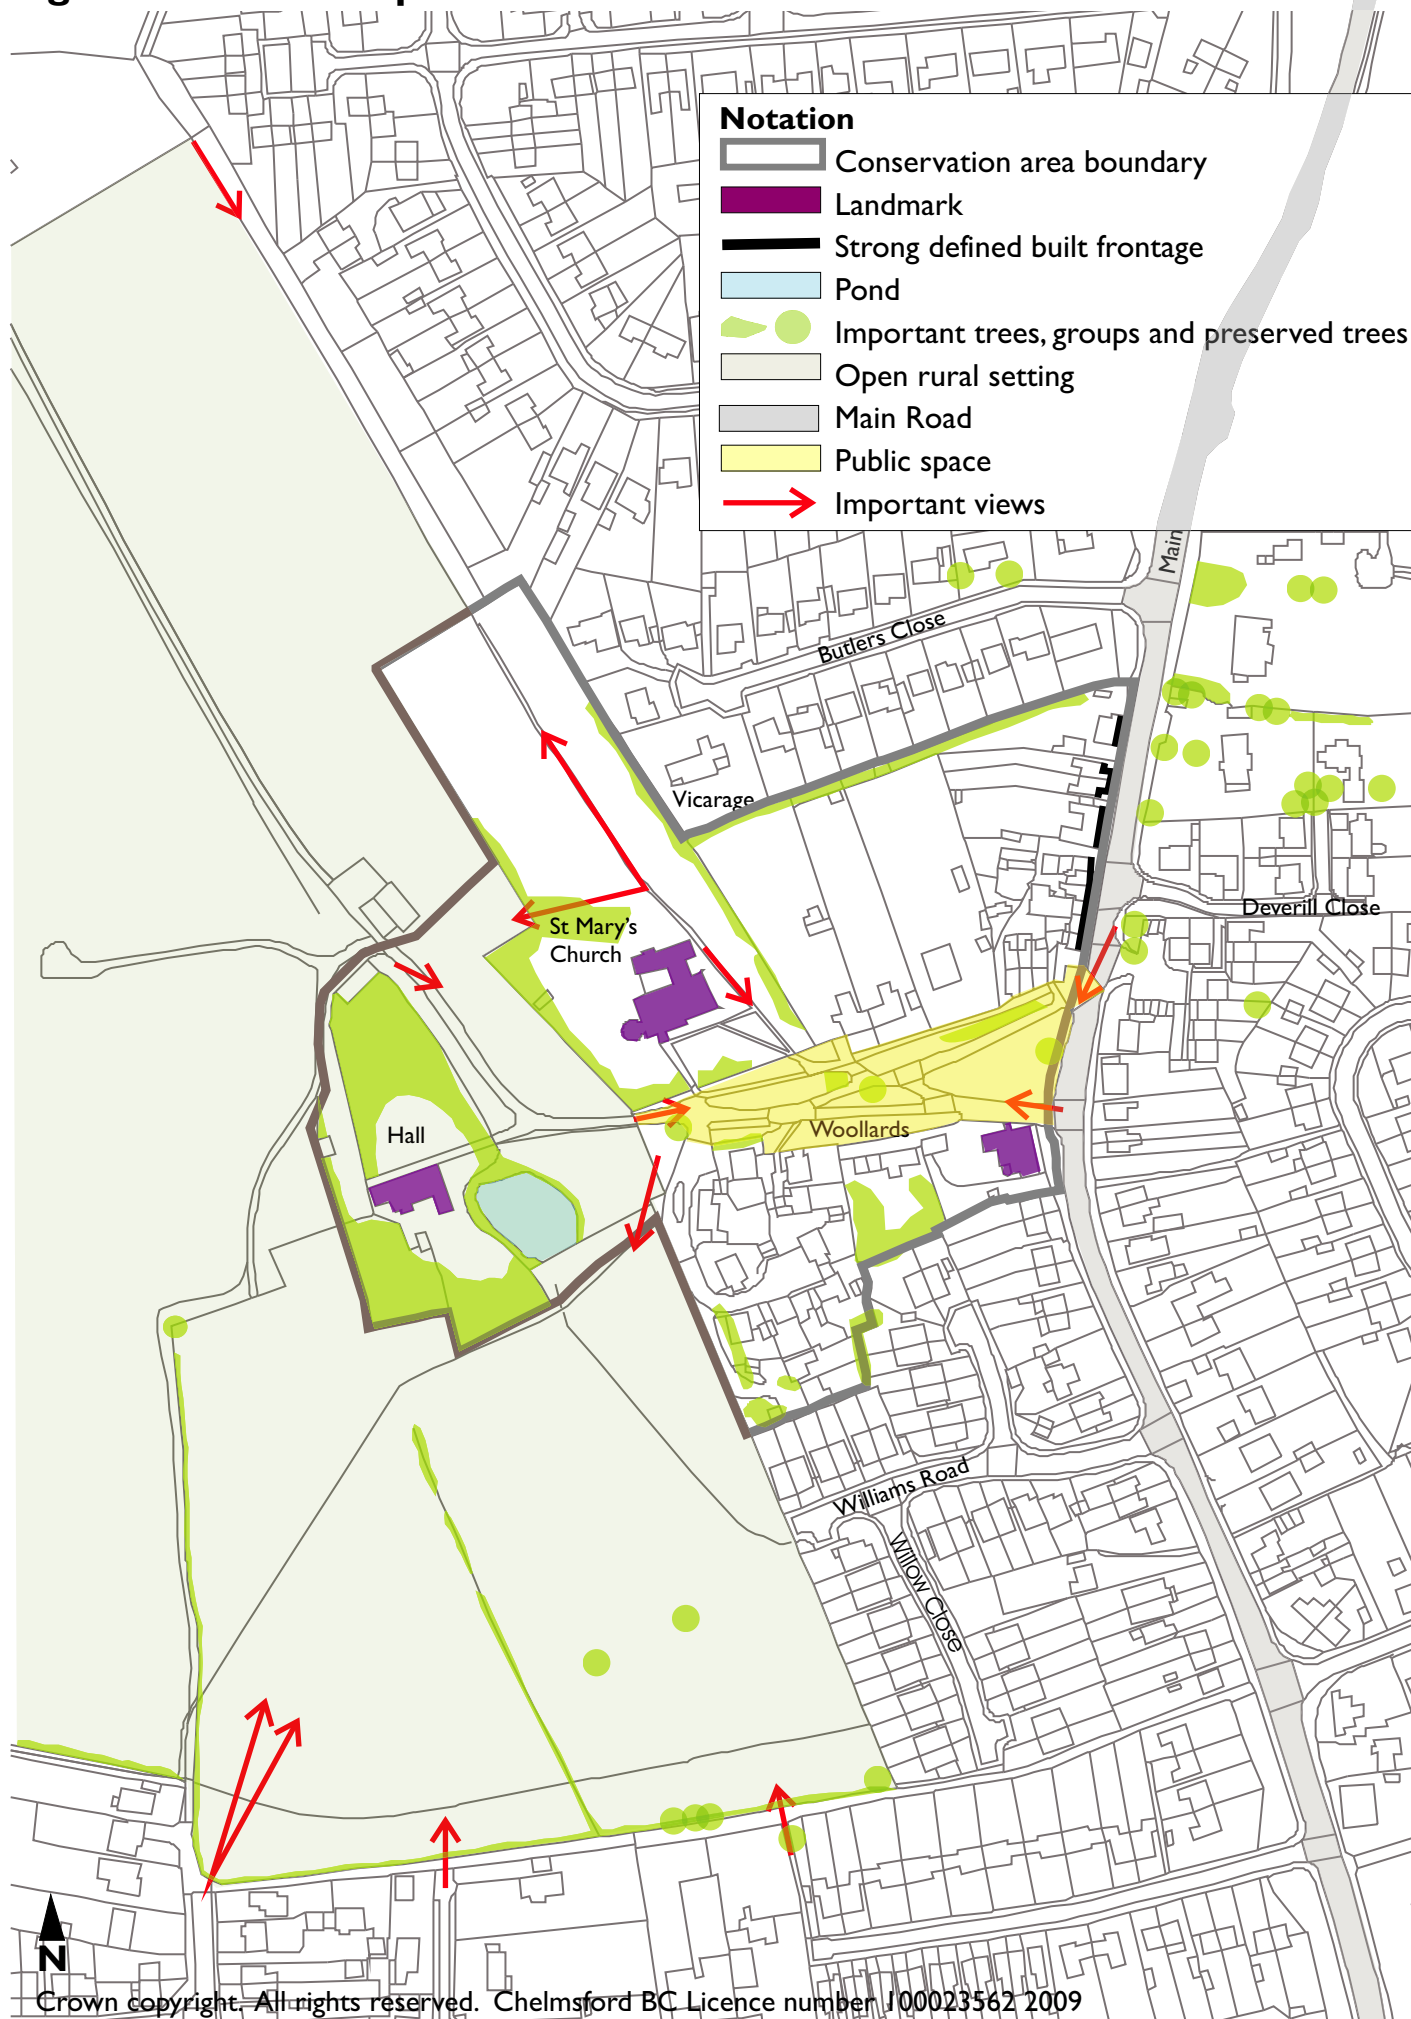
**Figure 29 - Townscape**

The conservation area is small, but there are three areas of different character, Main Road, Church Green and the Church Yard and Hall. Townscape analysis is provided on figure 29. Each character area is described below.

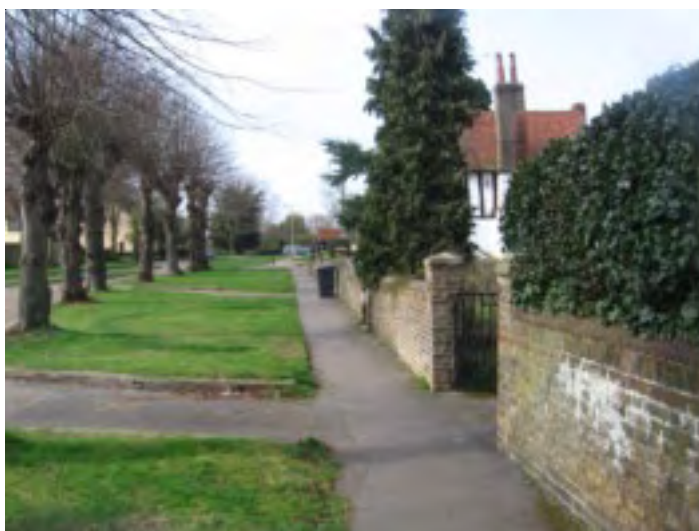
Figure 33 - Brick boundary walls backed by hedges

Boundary walls are prevalent, generally of red or yellow brick (figure 33), but of flint around the higher status Hall and churchyard. They are generally low in height. Simple railings (figure 34) and native hedged boundaries are also used. Timber fences are only used in hidden areas, to divide gardens.
