**RECORD OF DETERMINATION THAT LAND IS CONTAMINATED
LAND**

44 Chichester Drive, Chelmsford, Essex

Verification Report for
Rear Garden Remedial Works

19th April 2010
REV.01

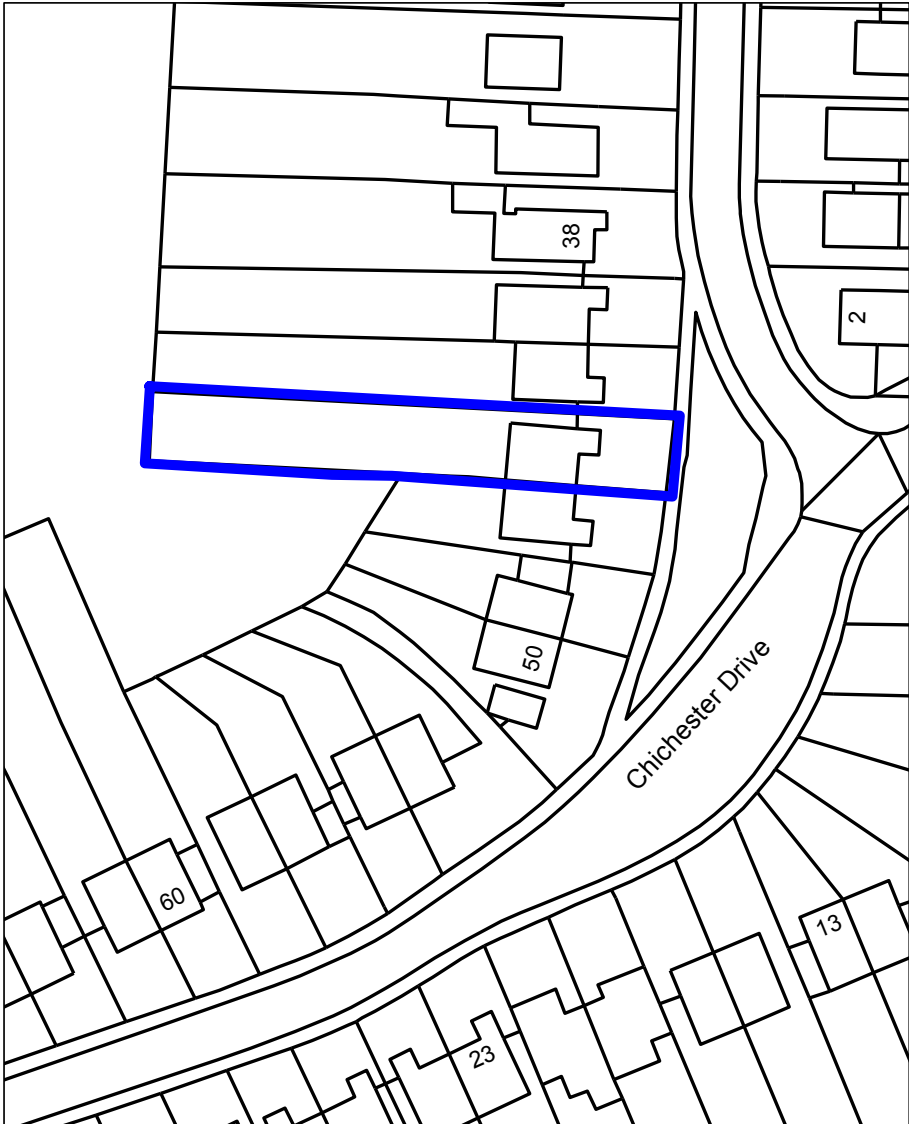
Figure 1.

44 Chichester Drive, Chelmsford CMI 7RY

(identified on the plan below as land within the blue boundary)
